## 2 Northpoint, San Francisco

Photos from 3/6/20 – 80% Structural Upgrade Completed

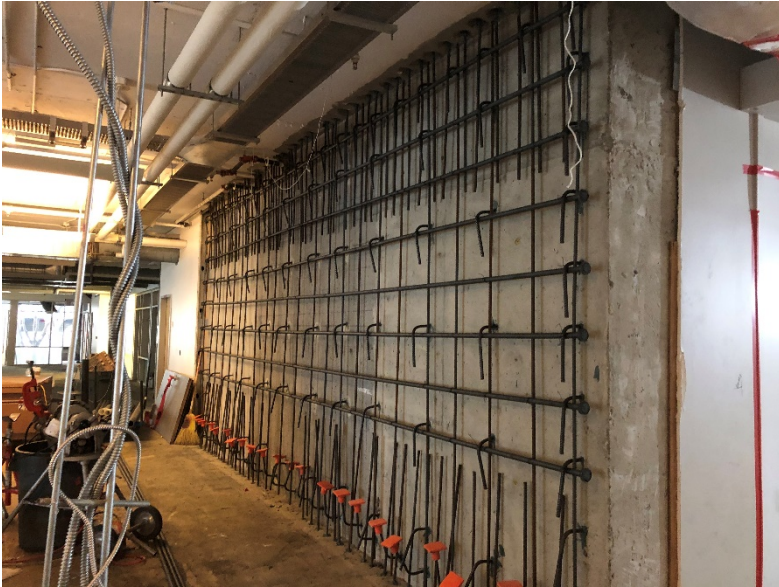
New metal bars installed in the wall to accept the new shear wall.

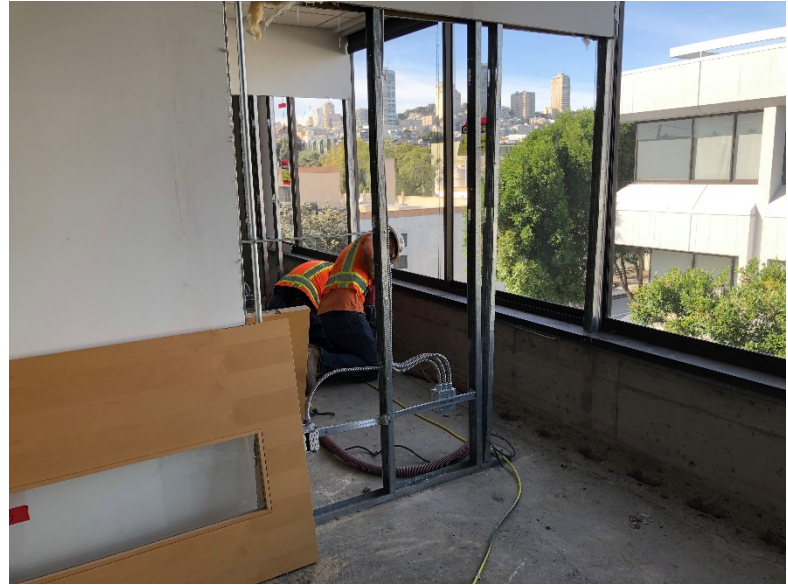
Installation of the perimeter collector beam.

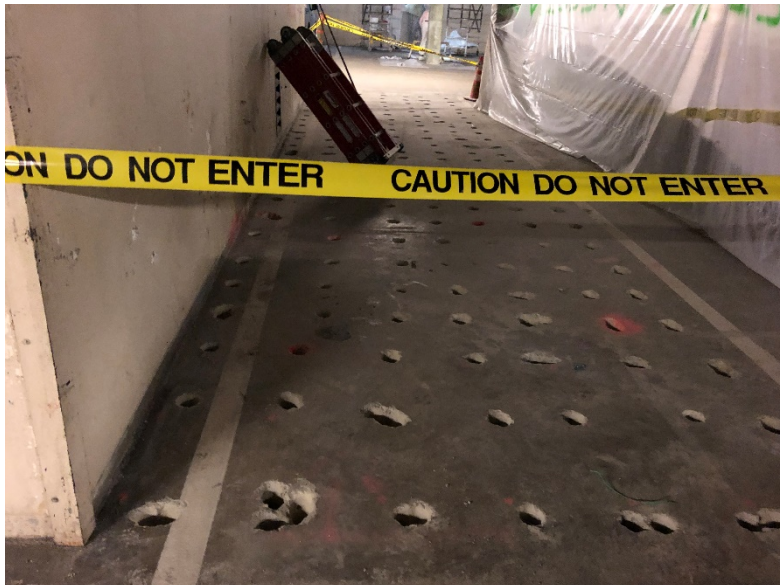
Holes drilled in the floor to accept the new metal bars.

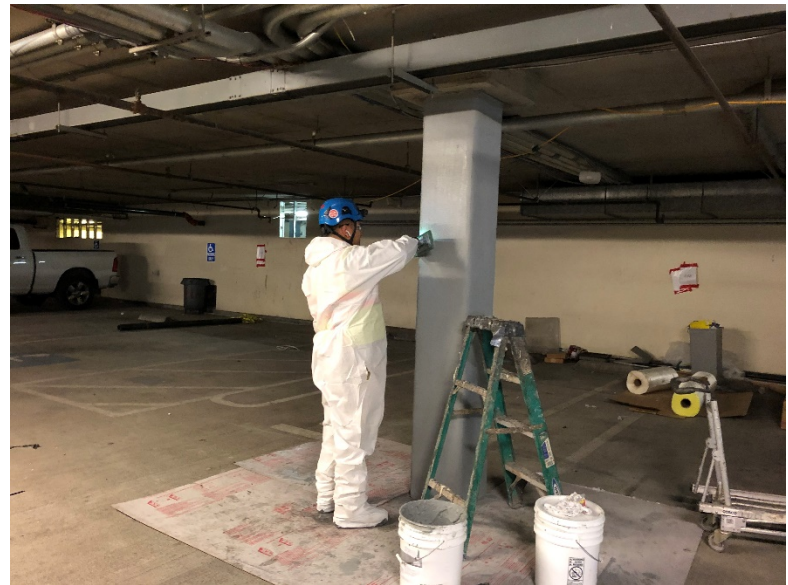
Carbon fiber wrap installed on columns in order to make stiffer.
